Technical Bulletin

Division: Automotive Section Title: Driveline/Axle Category: Technical TSB No. TS 06 05227

SUBJECT: FRONT DIFFERENTIAL OIL SEAL REPLACEMENT

MODEL(S): VITARA (SQ420 & SQ625L), GRAND VITARA (SQ625W), GRAND

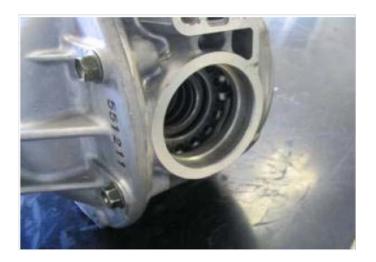
1. Completely degrease the inside of the sealing surface.

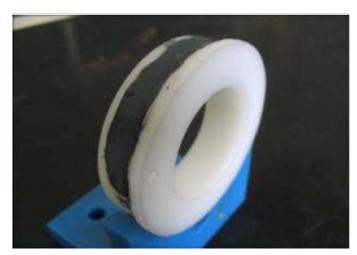
2. Apply oil resistant RTV sealant to the outer surface of the drive shaft support.

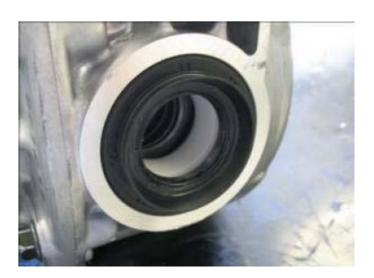
5. Install the oil seal as described in the service manual.
